## Cracks and Welds Detection Approach in Solar Receiver Tubes Employing EMATs

# Cracks and Welds Detection Approach in Solar Receiver Tubes Employing EMATs

## Abstract

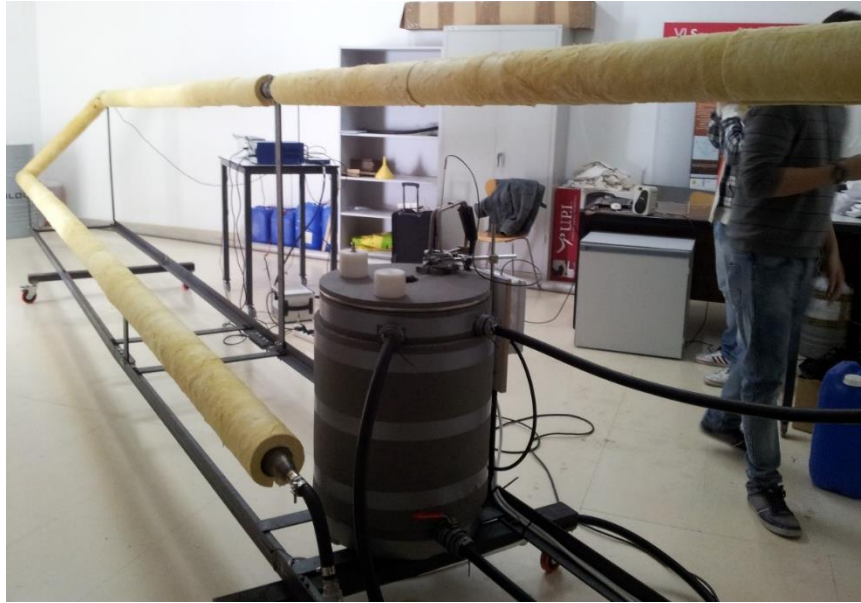
Figure 3 shows the real CSP test rig employed in the experiments.

**Figure 3.** CSP test rig.

The test rig is compound by two sections of pipe, one for warming, which simulate the circuit portion that absorbs solar radiation in a CSP, and return section, being the tubes of austenitic stainless steel. The ultrasonic waves are studied in the first section. The dimensions of the plant have been selected to reproduce at least two sections of solar collectors in actual installations, i.e. two 4.06 meters tubes welded to a connector of the same type of steel. The connector space is used to support the pipe by metal arms attached to the pillars supporting the reflecting mirrors. This space is considered ideal to place the transmitter / receiver of ultrasonic waves (see Figure 4).

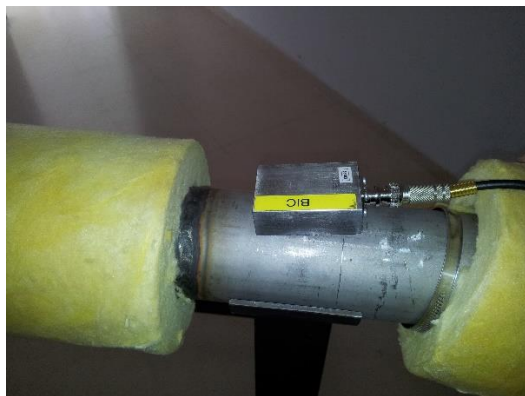
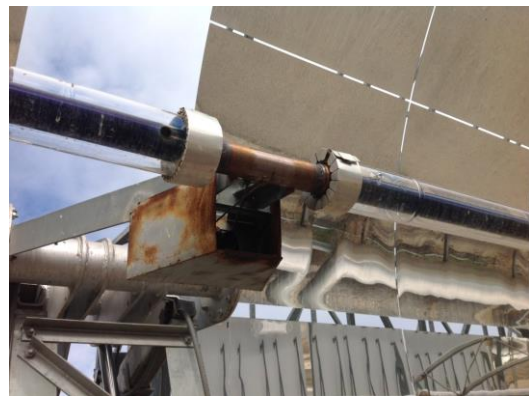
**Figure 4.** Detail of the junction of the collector tubes in the experimental platform (a) and in a real CSP in Almeria, Spain (b).

In a CSP, the collector tubes are usually welded to a short tube anchored to the support, shown in Figure 4. This part is the most critical component of the installation because it is prone to faults such as corrosion, bad welds or leaks. It must be considered these two welds, and its effect on the received signal, for a proper inspection of CSP collector tubes. Therefore, it is crucial to correctly identify these welds find the defects in the rest of the pipe, or bad welding.
